ACCRETIONS IN CEMENT SILOS : REASONS FOR FORMATIONS AND PREVENTIVE MEASURES

P C Kulkarni, VY Wani, S A Khadilkar and P Srinivasan

The Associated Cement Companies Ltd, India

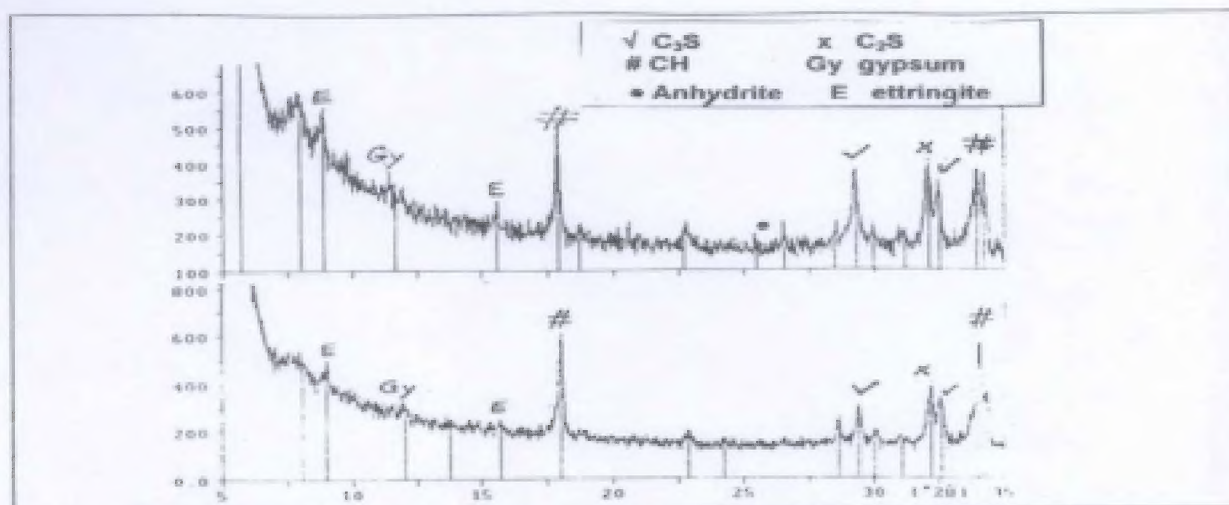
Fig : 4 XRD scan of the harder and the softer portion of the cement lump.

The harder portion was observed to be composed of C_3S , C_2S , Portlandite, anhydrite, Gypsum, Ettringite while the softer outer portion showed C_3S , C_2S , Gypsum, Ettringite and lesser Portlandite, this portion was conspicuous in absence of anhydrite.

Subsequently the grinding unit reduced the gypsum added to the slag in grinding of slag and improved ventilation in the storage silo reduced problem of lump formation.

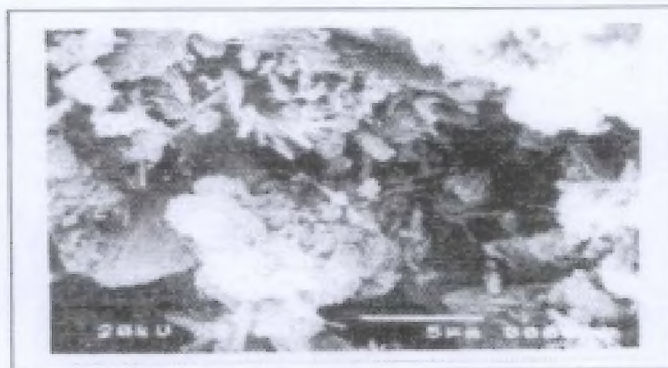
Under electron microscope, the hard part showed fibrous like crystals of anhydrite and gypsum. The quantity of these crystals decreases away from the hard part. Portlandite crystals are also seen in this hard part (Fig:5). However, more crystalline type is seen in the softer region of the samples. Presence of very fine needle like ettringite is also observed throughout the samples (Fig:6).

Fig:5 Anhydrite crystals, fine needles of ettringite in hard part

A temperature gradient in the cooler areas of the silo i.e. near to the wall which causes condensation of water which causes the hydration of the cement grains forming portlandite and developed ettringite crystals resulting into a hard crust. In this portion the water hydrates the dehydrated gypsum produced either during grinding or in the storage silo. Subsequently, more cement grains must have got adhered to this hard crust forming the softer part of lump which shows presence of gypsum and thinner crystals of ettringite.

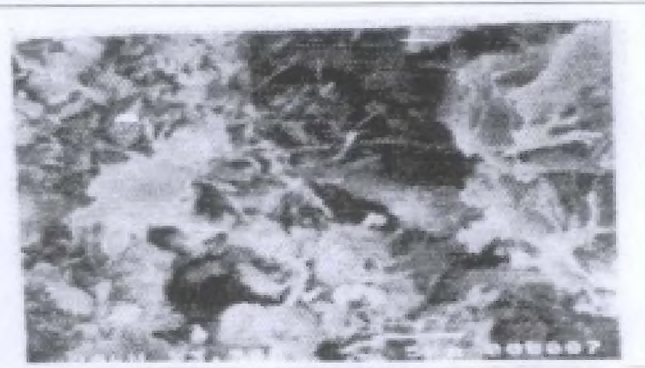
Fig:6 Very fine ettringite needles with prehydrated cement grains in soft part of the lumps

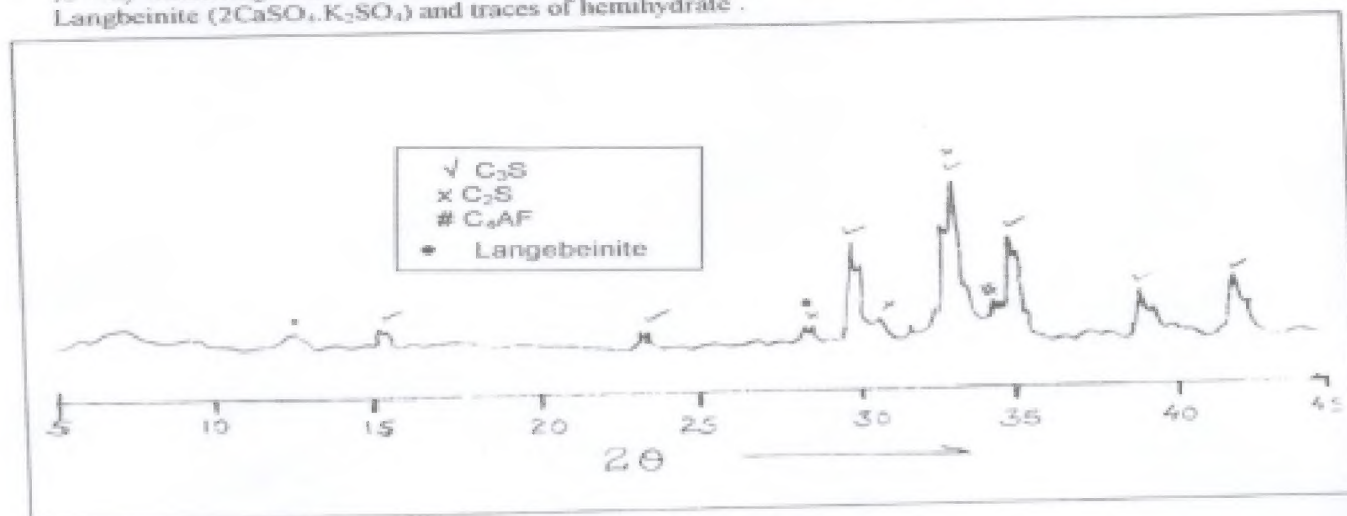
X-ray diffractograms of the sample is shown in, the sample is composed of C₃S, C₂S, C₄AF and Calcium Langbeinite (2CaSO₄.K₂SO₄) and traces of hemihydrate.

Fig : 7 XRD of the soft Lump (Case - II)

The evaluations carried out indicate that in this case the soft agglomeration is due to formation of syngenite traces initiated by the presence of Calcium langbeinite present in the clinker and traces of hemi-hydrate present in the cement .However this could result in harder lumps if there is sufficient water condensation in the cooler areas of silo.

The agglomeration was brought under control by reducing the gypsum levels in combination with control on the cement mill temperature . As a precaution adequate ventilation was provided in cement silo to avoid agglomeration even if the cement is stored for a longer time .
